## Becks Creek wetland

### Site Details

# SUPPORTING OUR Manuherekia wetland network

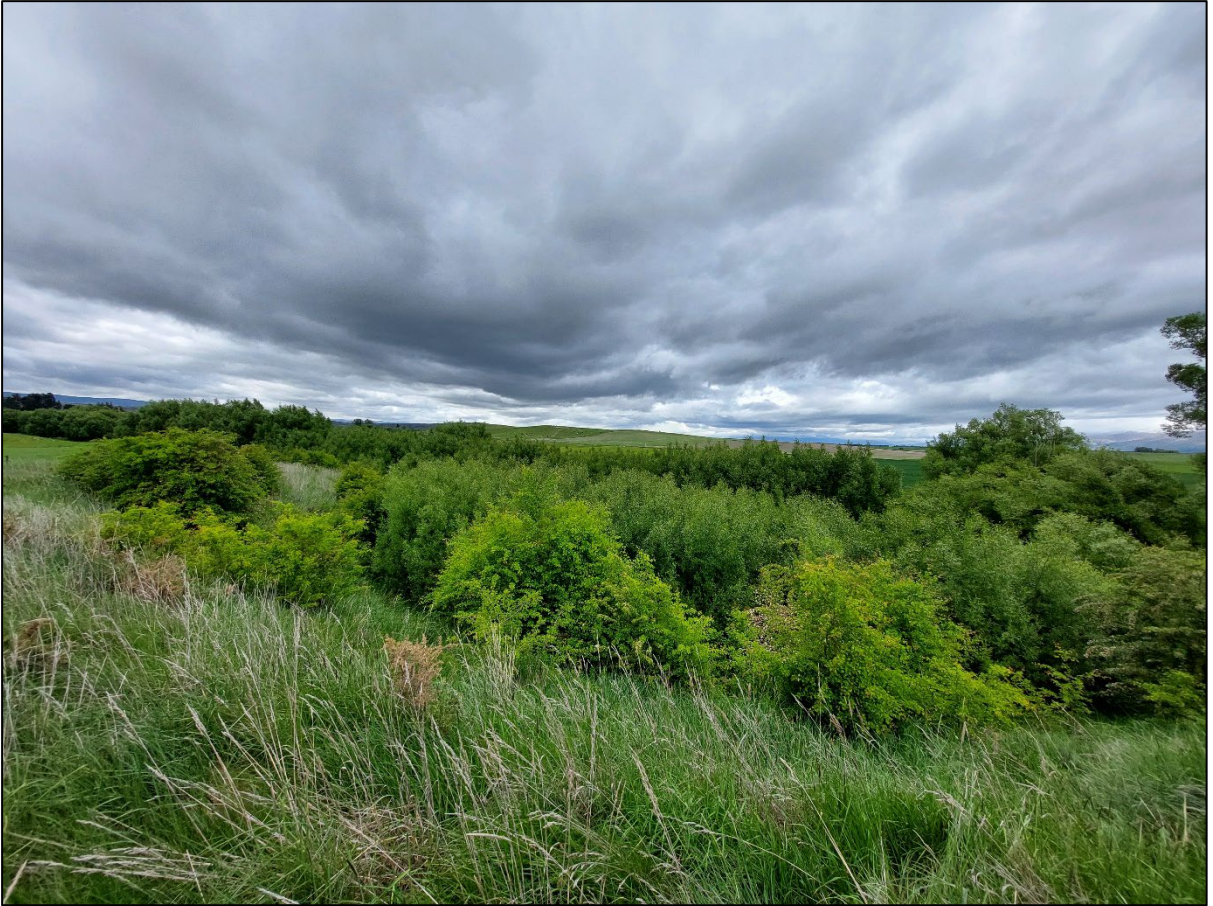
Photo taken November 21<sup>st</sup> 2024.

Heavily infested with willows and other woody weeds with few examples of indigenous vegetation. Currently not excluded from stock and grazing pressure has further impacted the values.
