# Habitat Restorations Aotearoa Ltd.

## Waiora Manuherekia

### Planting proposal for O'Sullivan's (Cambrians Wetland – old coal mine)

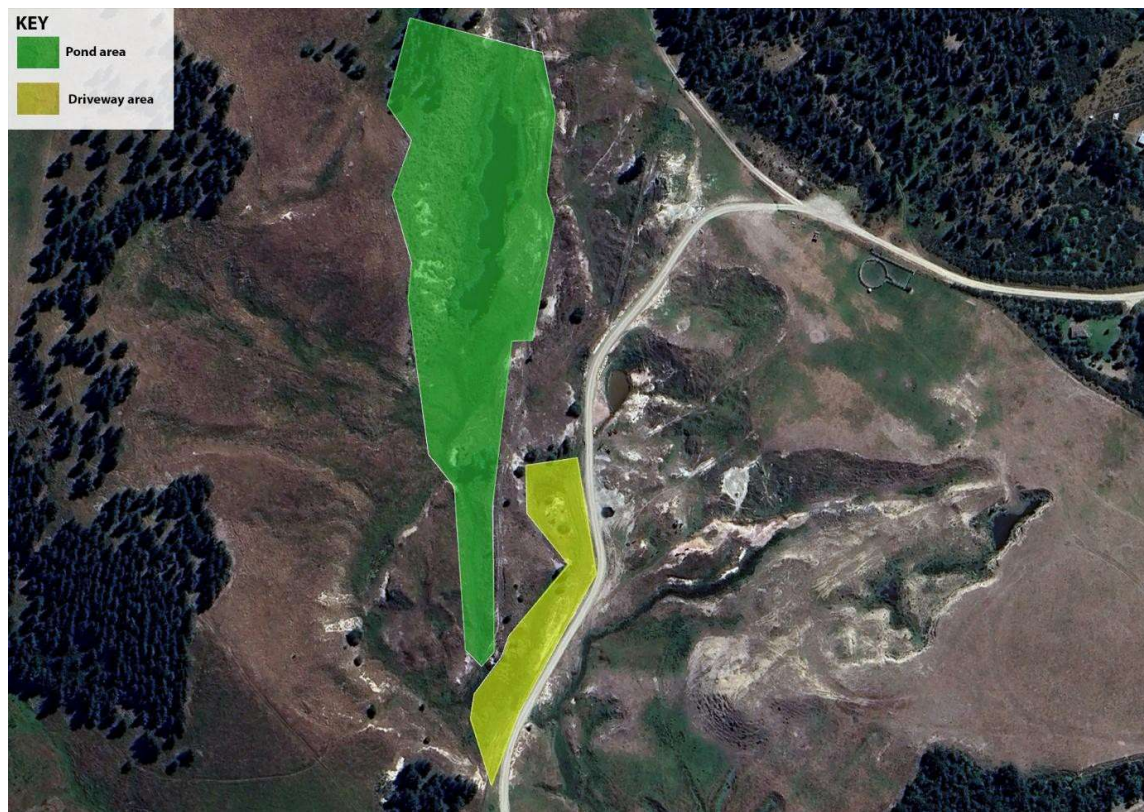
Figure 19 Plan view of planting areas.

The planting budget allows for some pockets of planting within the area, including around the historic coal pit pond, and a few pockets of planting either side of the driveway (Figure 19). The pond currently has raupō within it and some carex at its edge (Figure 20). There is a track that goes partially around the pond, and it is intended that this will be continued around the entire pond. The area around the pond can become inundated sometimes (approximately “gumboot deep”).

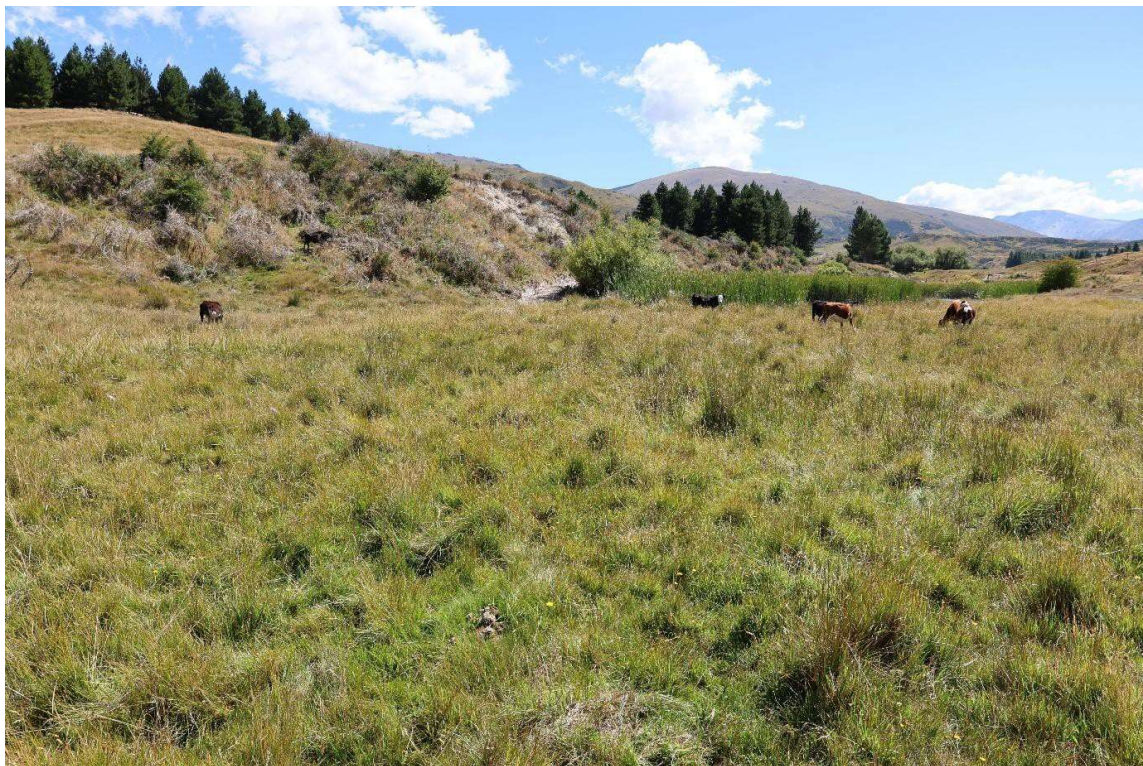
Figure 20 Photograph looking north towards the historic coal pit pond.

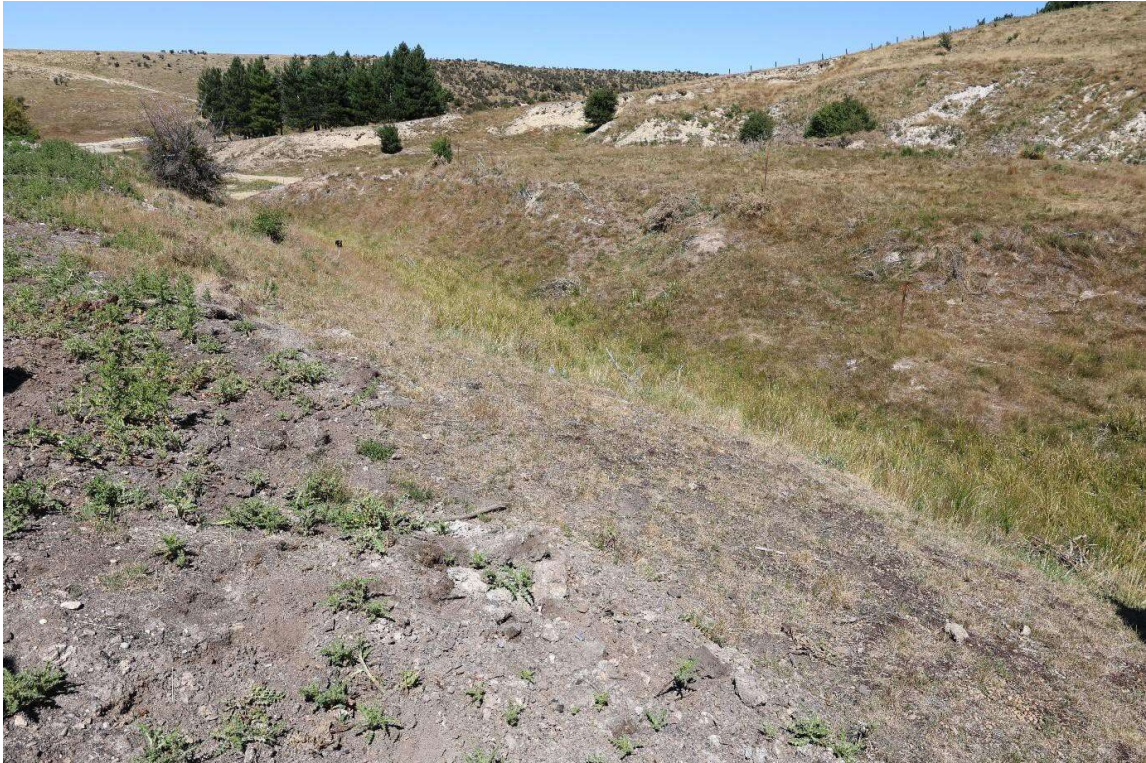
*Figure 21 Photograph of the western side of the driveway.*

The side of the driveway is banked (Figure 21). Although the top of the bank is dry and has challenging growing conditions, the middle of the bank appears to be growing plants. Carex would likely be a good option at the bottom of the bank. South-west along the driveway there is some substantial carex regeneration occurring (Figure 22).

It is recommended that planting establishment along the driveway is done from the bottom of the bank, working upwards. The plants at the bottom will have more tolerance and are likely to be more successful. Their establishment will then make it easier for plants further up the bank to grow. It is recommended that planting is at 2m spacings.

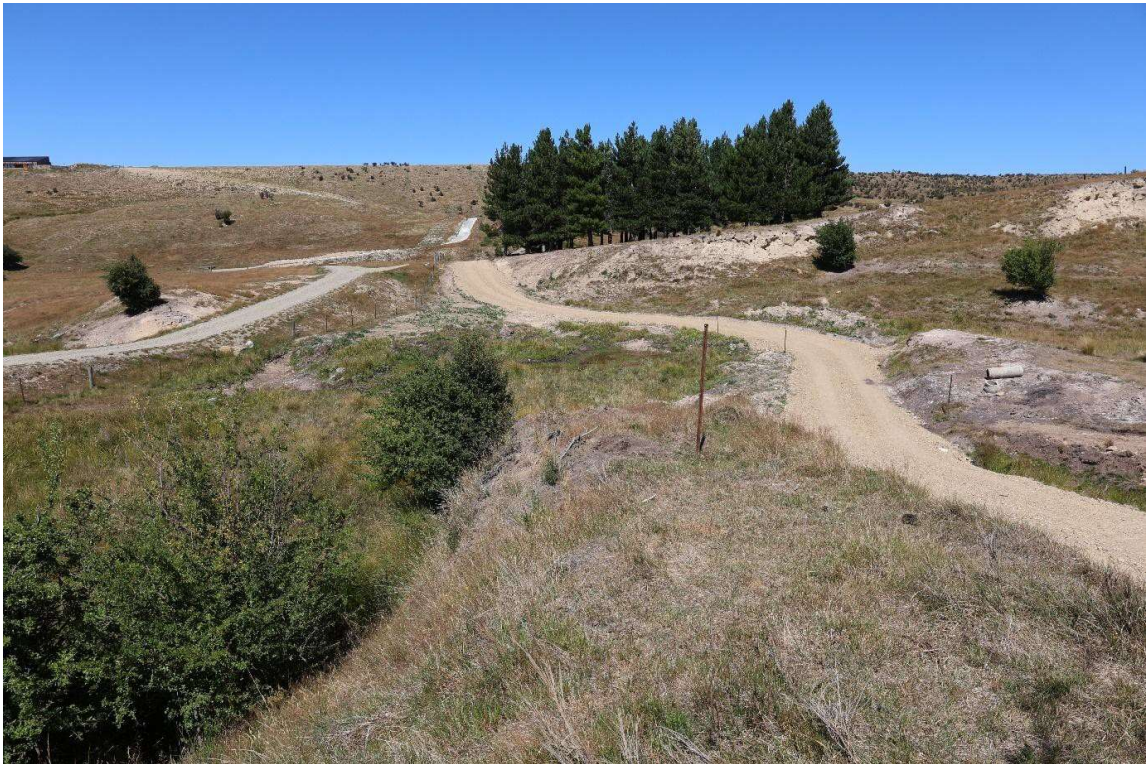
*Figure 22 Photograph of the eastern side of the driveway, looking south towards an area of regenerating carex.*
